NAVAL WEAPONS STATION CHARLESTON FLEET MOORINGS UNDERWATER INSPECTION REPORT

JUNE 1985

OCEAN ENGINEERING
AND CONSTRUCTION PROJECT OFFICE
CHESAPEAKE DIVISION
NAVAL FACILITIES ENGINEERING
COMMAND
WASHINGTON, D.C. 20374

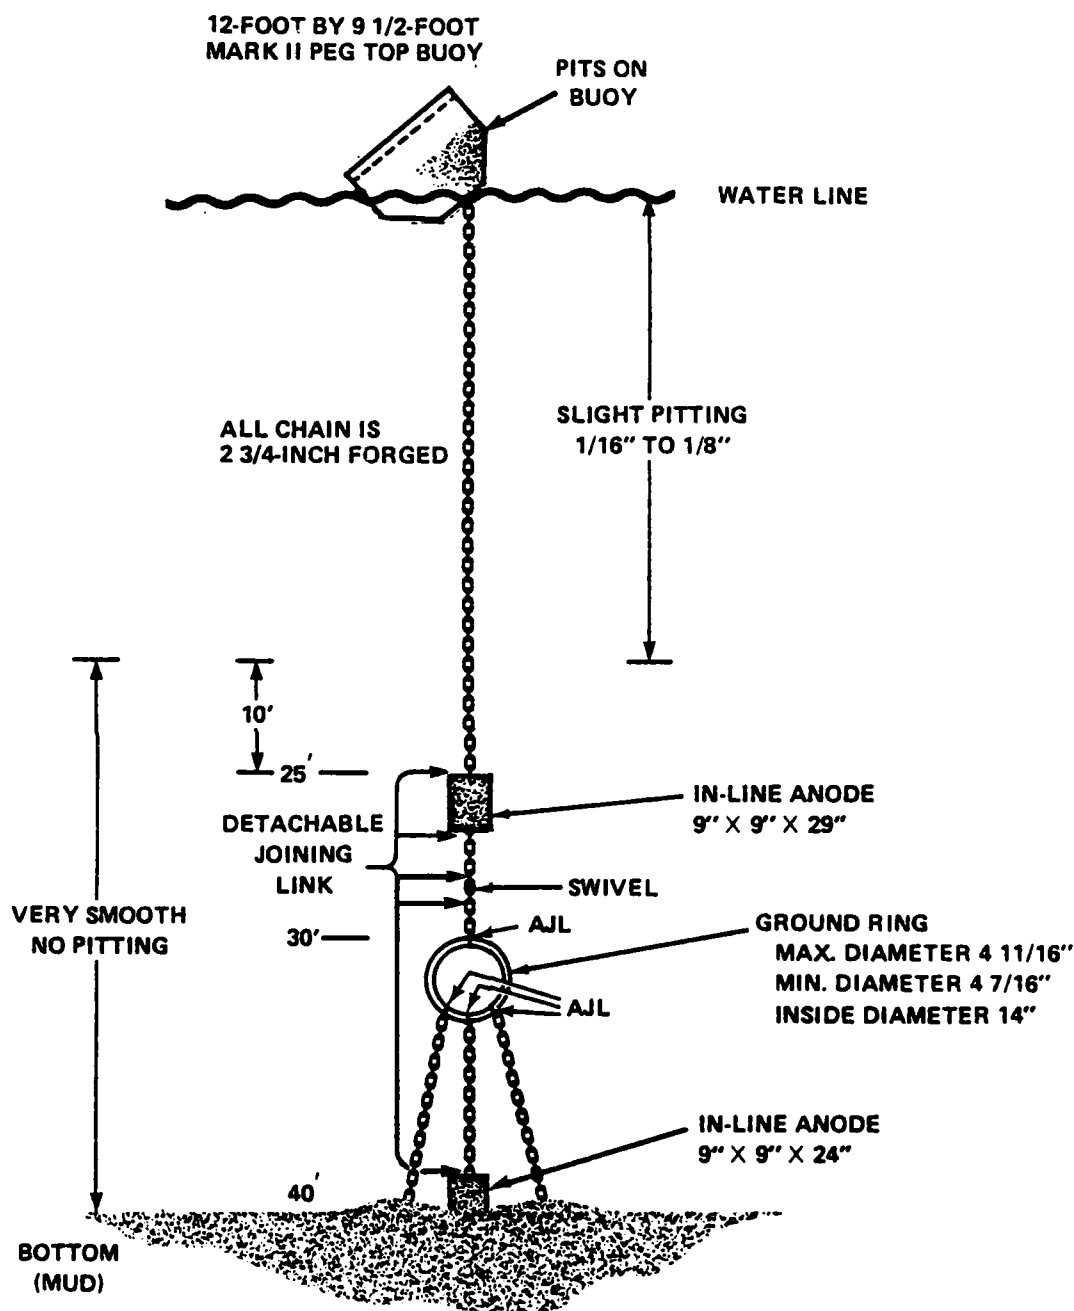
Figure A-4 Auxiliary Mooring

This Mark II Peg Top Buoy with hawse pipe measures 12 feet in diameter by 9 1/2 feet high. The buoy has a 54° list which could be caused by failure of its watertight integrity. It has two wooden fenders which are covered with thin steel strips and a 1/4-inch thick steel plate covering the topside. The wooden fenders are splintering and the upper and lower steel plates are badly rusted, loose, and layers of rust are flaking off at the waterline. In addition, the buoy has 1/8-inch deep pitting in its bottom, and the top has a heavy coating of guano. In general, this buoy is in very poor condition and should be removed from the water before it sinks.

The 2-inch riser chain is in good condition with all measurements greater than 90 percent. The chain is heavily coated with marine growth with pitting and rust towards the surface. An in-line anode was located at 25 feet. The ground ring was located at 30 feet and is in good condition.

- o The buoy should be removed and the cause of its list determined and repaired.
- o All voltmeter readings are within accepted values.
